MILLENNIUM
CHALLENGE CORPORATION
UNITED STATES OF AMERICA

EVALUATION BRIEF | MARCH 2020

EXPANDING URBAN WATER SUPPLY AND DRAINAGE IN MOZAMBIQUE

Benefits from infrastructure required complementary investments

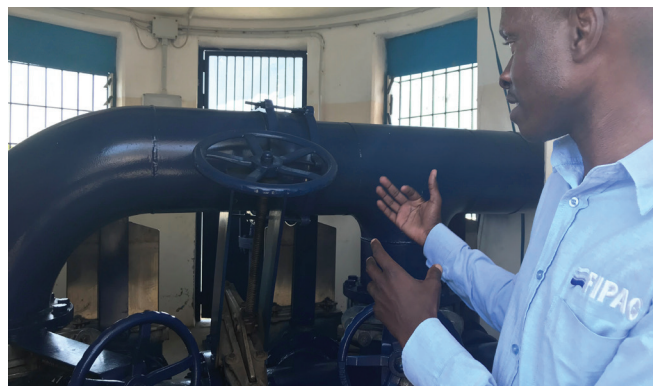
FIPAG staff showing pump at dam.

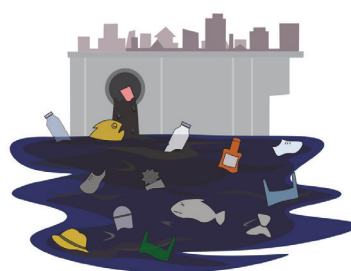
Municipal sanitation companies are unable to maintain the drains.

Communities continued to deposit trash in the drains.

↓
Trash resulted in clogged canals.

In addition, infrastructure should be paired with sufficient capacity building to maintain the infrastructure and maximize benefits. The companies created to manage the drains lack the capacity to maintain investments in the post-compact period.

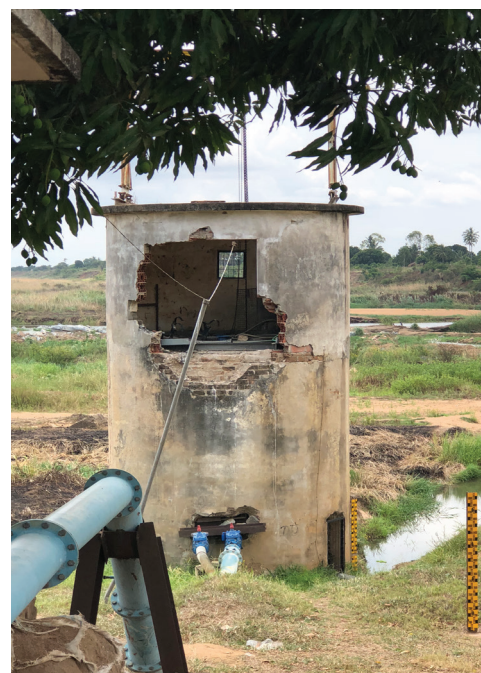
The Mocuba works doubled the volume of water available to customers and increased service hours. However a massive flood in 2015 destroyed the bank intake system and shifted the course of the river, negating future benefits.

Damaged intake tower wet-well in Mocuba post 2015 flood.

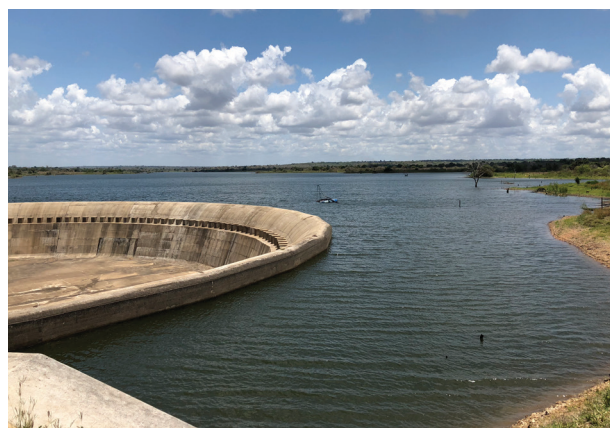
The Nacala Dam increased the potential water supply capacity in Nacala city. However, the accompanying water treatment plant and transmission pipes were not completed due to contractor non-performance—and so, the outcomes from this intervention had not materialized.

The new Nacala dam, completed in 2013.

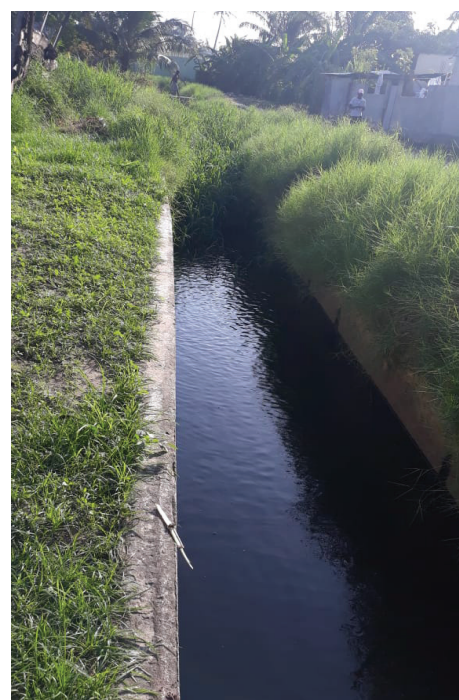
Intact Quelimane drainage channel with some overgrowth.
